RELIABILITY OF PORTABLE DRY CHEMICAL  
FIRE EXTINGUISHERS IN USE  
ON MOTORBOATS

W.C. HELGESON

U.S. Coast Guard Research and Development Center  
Avery Point Groton, Connecticut 06340

FINAL REPORT

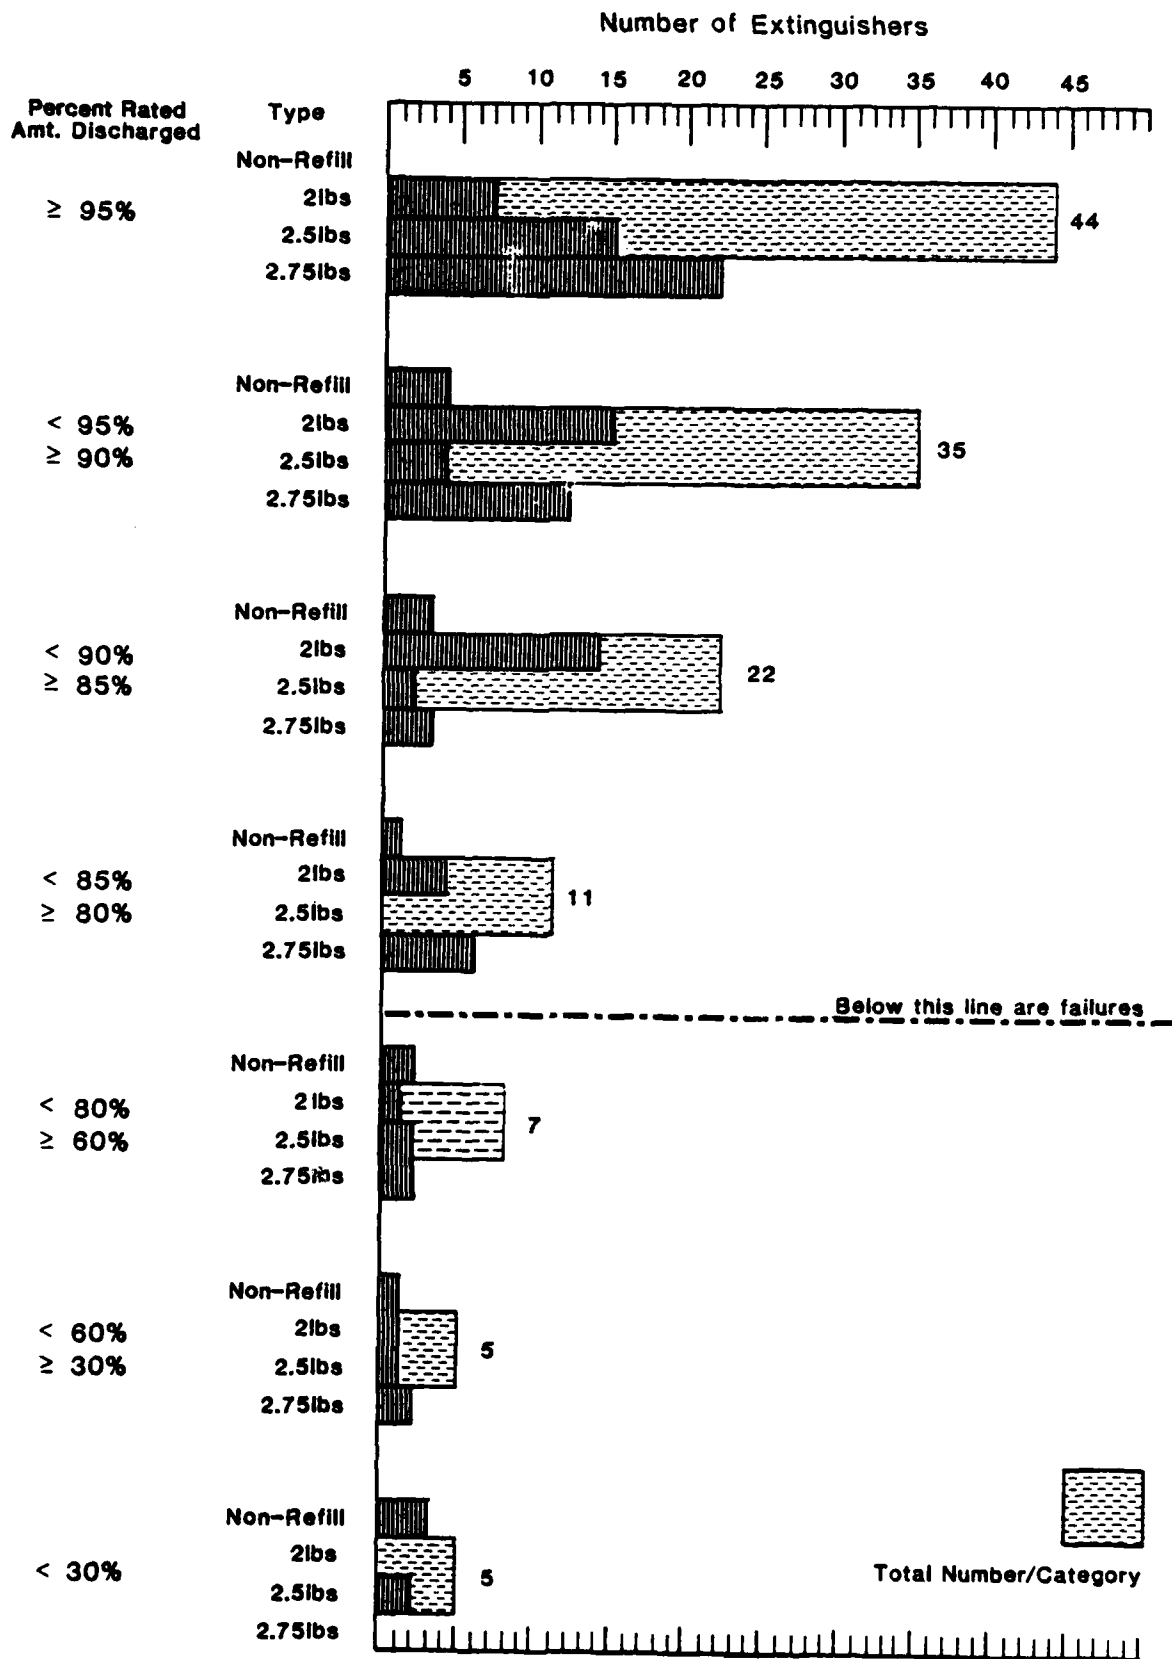
FIGURE 1  
COMPARISON OF DISCHARGE AMOUNTS

The amount of powder expelled compared to the rated capacity is shown in Figure 1 for all the extinguishers. Over half of the extinguishers discharged 90% or more of their rated capacity. Seventeen (17) of the one hundred thirty (130) extinguishers failed one or more of the tests. Appendix A describes each failed extinguisher. Tables 1 through 5 categorize the extinguishers by manufacturer and dates. Figure 2 shows pictures of the cut-open, failed extinguishers.

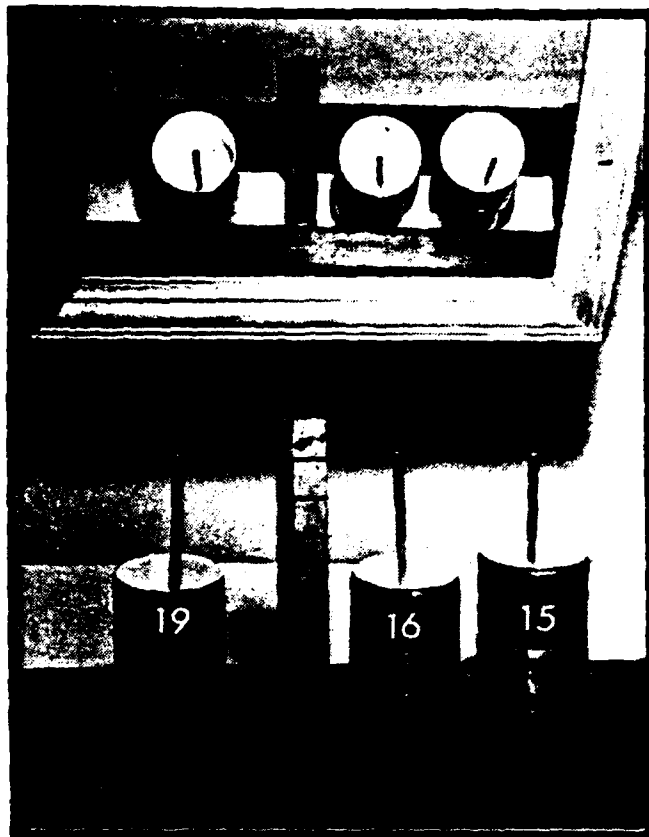
(a) This shows how much agent remained in three of R.C. Industries' non-refillable bottles

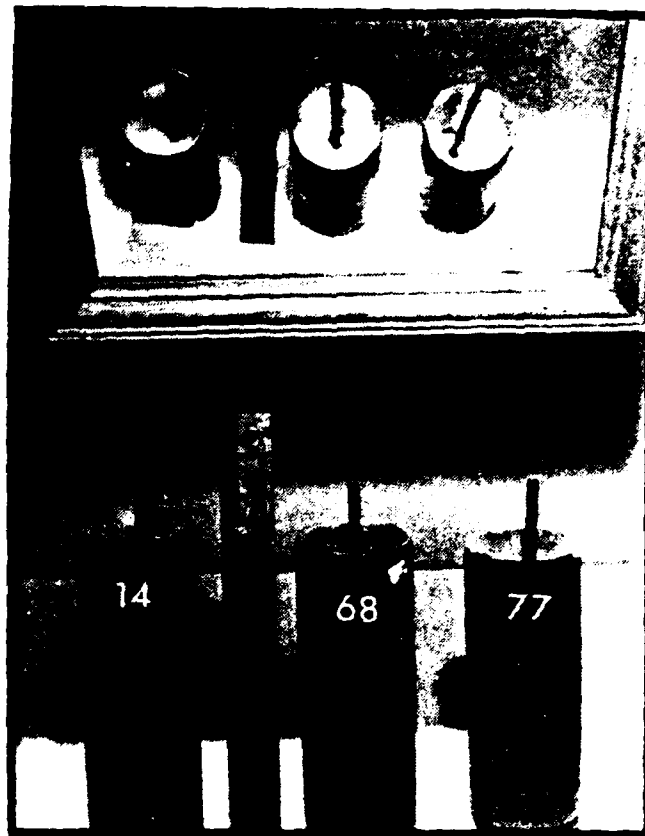
(b) This shows packed agent in R.C. Industries' refillable bottles  
Note that the powder did not flow in around the marking stake.

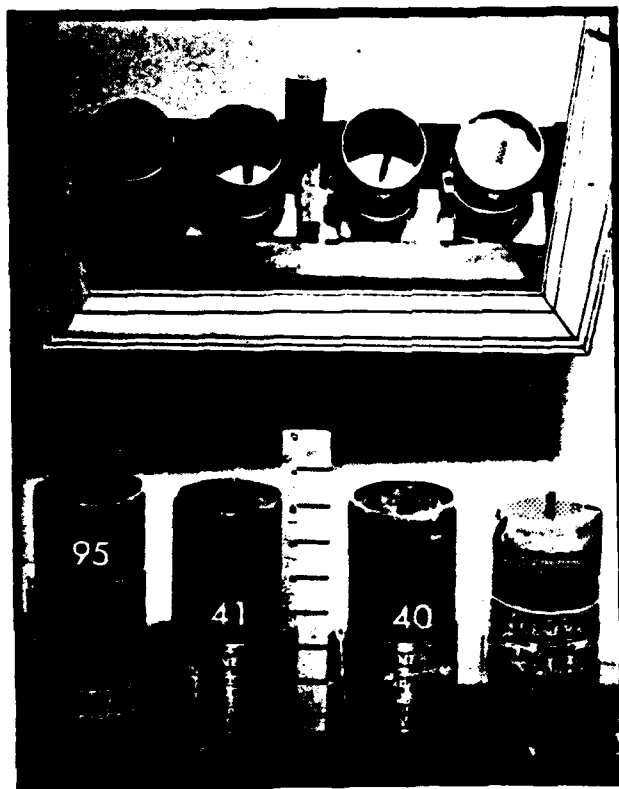
(c) This shows the oldest extinguishers. Note the caking in all three of 41, 40 and 97. A picture of the caked powder from 97 is on the next page.

3. (40)	2 1/2 lb.	1960	General Fire Ext. Corp.	D 92270	39.06	6.2
The agent inside was light blue in color, and <u>caked</u> .						
4. (97)	2 1/2 lb.	1960	General Fire Ext. Corp.	C-58438	16.56	3.2
The siphon <u>tube was packed</u> and <u>caked</u> at the tip. Severe tapping only loosened some of the agent. Contents <u>caked</u> .

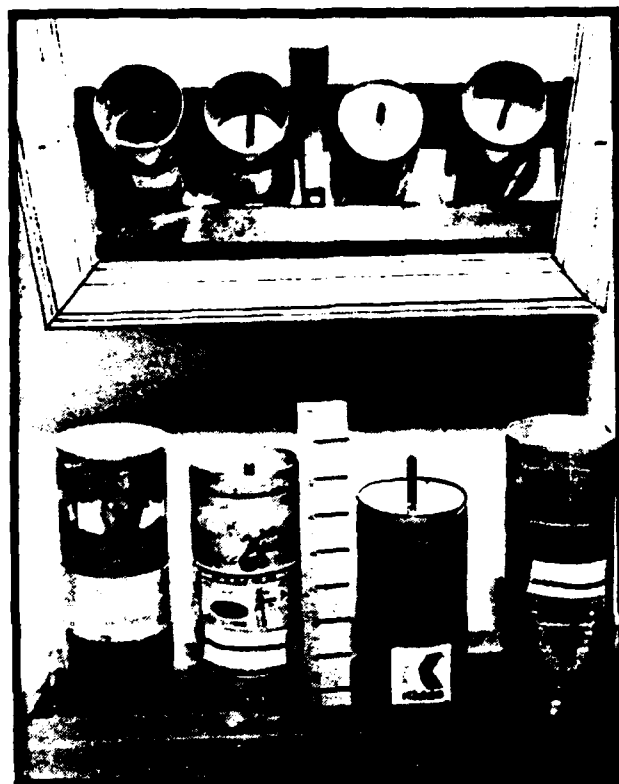
(d) This is a picture of older bottles. Note lumps in 76, corrosion on 65 and 127. 127 was a non-refillable that failed completely. 69 was clogged at the valve end of the siphon tube.

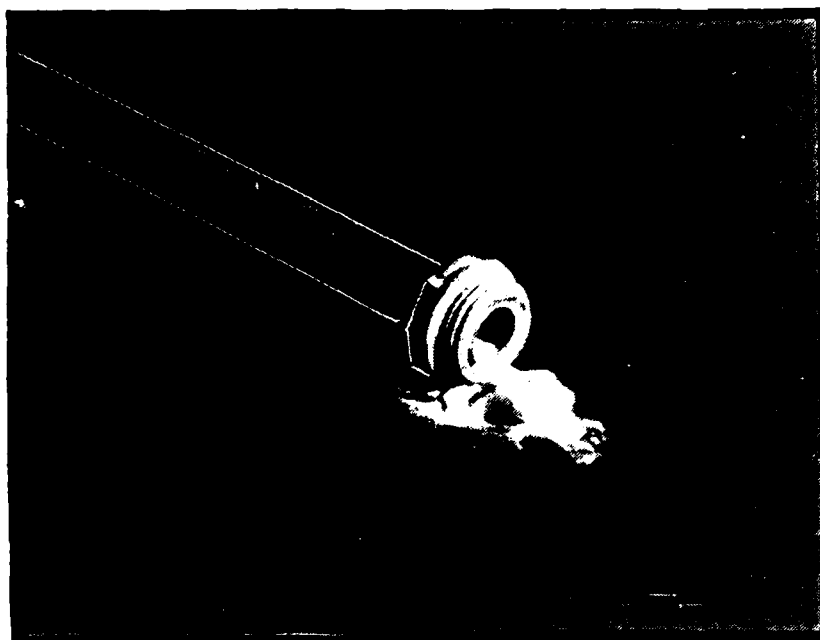
(e) This shows the caked plug from "Fyr-Fyter" survey number 69.

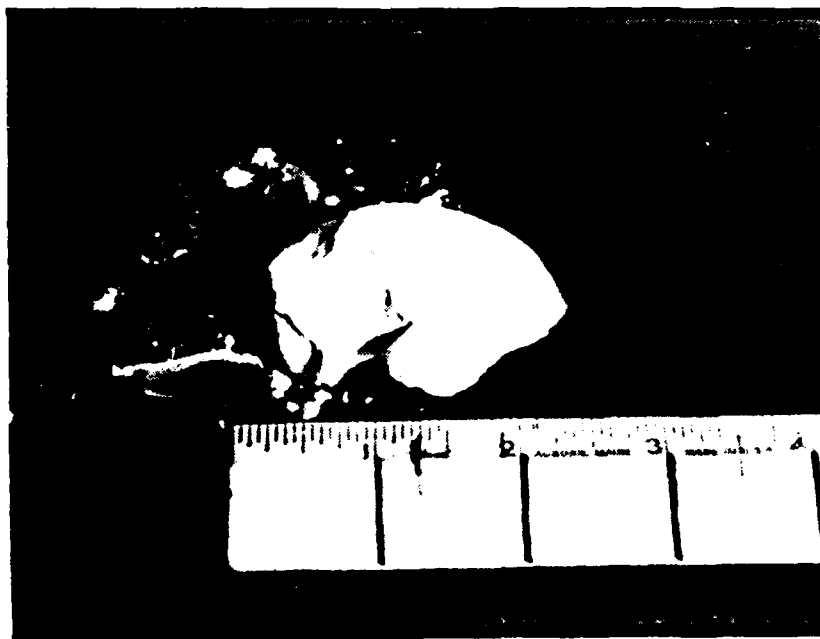
(f) This shows a caked lump of agent from "General" survey number 97.

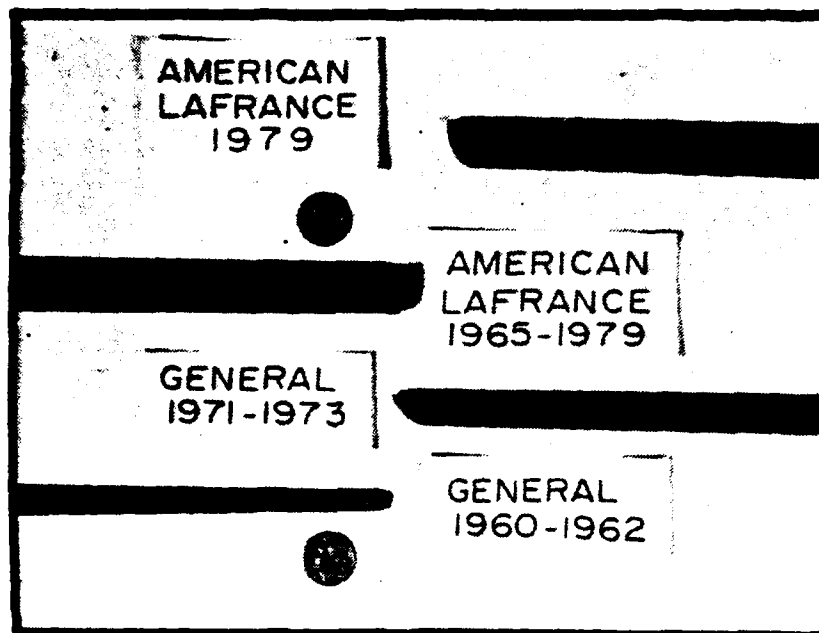
Although there was some packing and caking of the chemical agent, these conditions did not occur enough times to merit another survey or corrective measures. There also has been a design change which should lessen the effects of any packing. The siphon tube size has been increased from 5-7mm on 1960-1969 models to 8-14mm on the 1970-1982 models. Since 1975 some of the tubes have circular cut-outs or are cut at an angle to increase the surface area of the end of the tube. Figure 3 shows the different tubes photographed next to a dime to indicate the size.

Comparison of typical 1960's small siphon tube to the newer, larger tubes. The small tube is copper. The rest are rigid plastic.

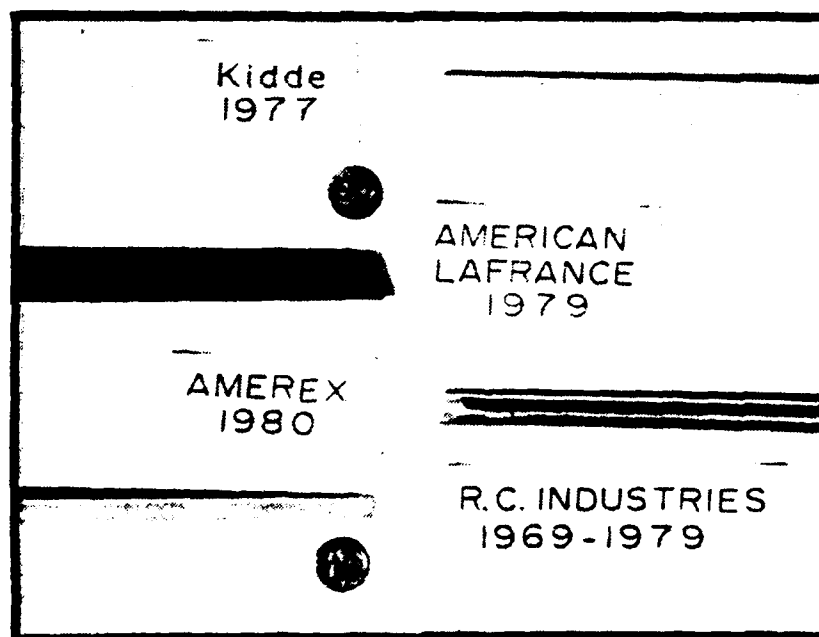
Comparison of 1970's siphon tubes. Kidde and American LaFrance have rigid plastic tubes. Amerex has an aluminum tube. R.C. Industries has a semi-flexible, plastic tube.
